Eliminating edge deposits – BTG's customized solution cuts costs and boosts productivity

Deposit build-up on the Yankee cylinder can impair production efficiency, compromise quality, and increase the need for blade changes and Yankee regrinding. Developed through hands-on experience at leading mills, BTG's new customized service package eliminates the problem, for potential savings of up to €100,000 a year.

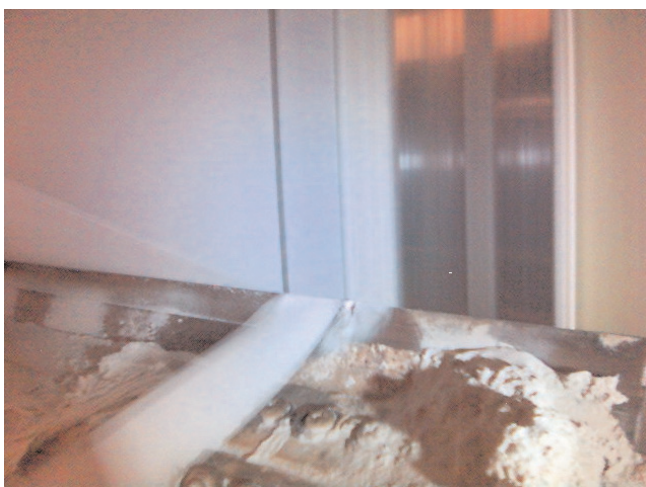
Figure 1: Typical white fiber/fines build-up

Subsequent 'edge build-up' or 'edge deposit' can contain fibers, fines, fillers and other dissolved components (hemi-celluloses, wet strength agent and so on), along with coating chemicals. This contamination can be seen as whitish or white-brown 'belts' around the Yankee edges. Hard water is another possible source of edge deposit.

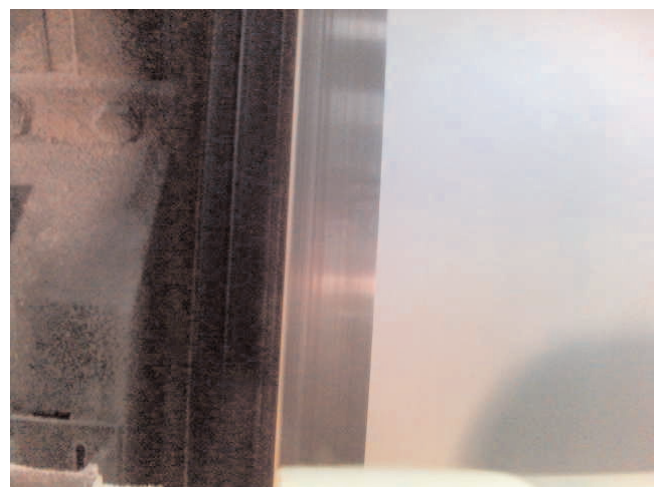
Figure 2: Very clean Yankee edge
